# **Home Report**

**122 Shaw  
Crescent,  
Aberdeen, AB25 3BU**

# Single Survey

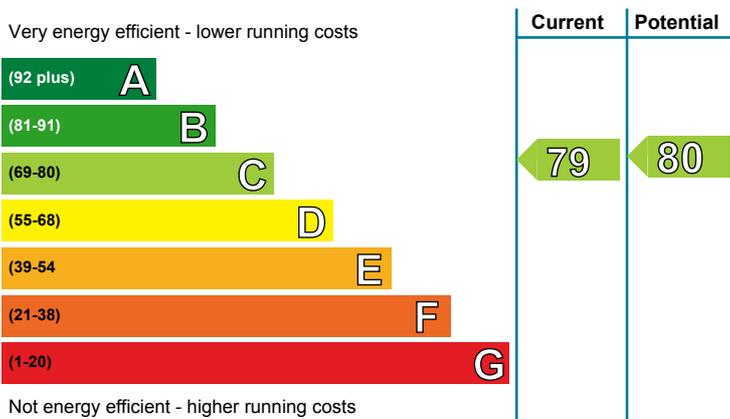
## Energy Efficiency Rating

This graph shows the current efficiency of your home, taking into account both energy efficiency and fuel costs. The higher this rating, the lower your fuel bills are likely to be.

Your current rating is **band C (79)**. The average rating for EPCs in Scotland is **band D (61)**.

The potential rating shows the effect of undertaking all of the improvement measures listed within your recommendations report.

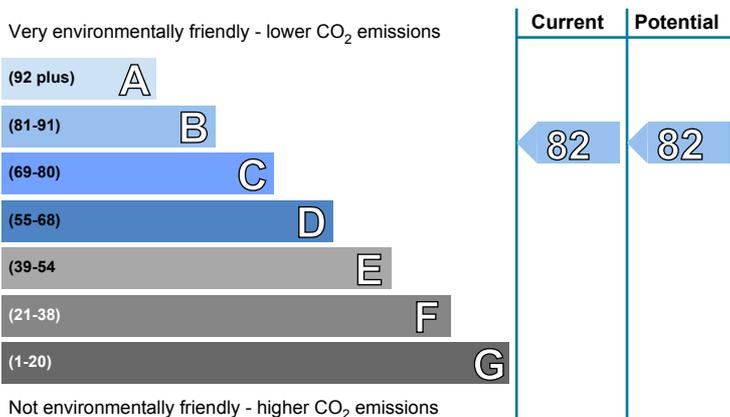
## Environmental Impact (CO<sub>2</sub>) Rating

This graph shows the effect of your home on the environment in terms of carbon dioxide (CO<sub>2</sub>) emissions. The higher the rating, the less impact it has on the environment.
