single survey

survey report on:

Property address	14 Bishopston Circle Portlethen Aberdeen AB12 4XY
Customer	Ewan Hannan & Sarah Moir
Prepared by	Graham + Sibbald LLP

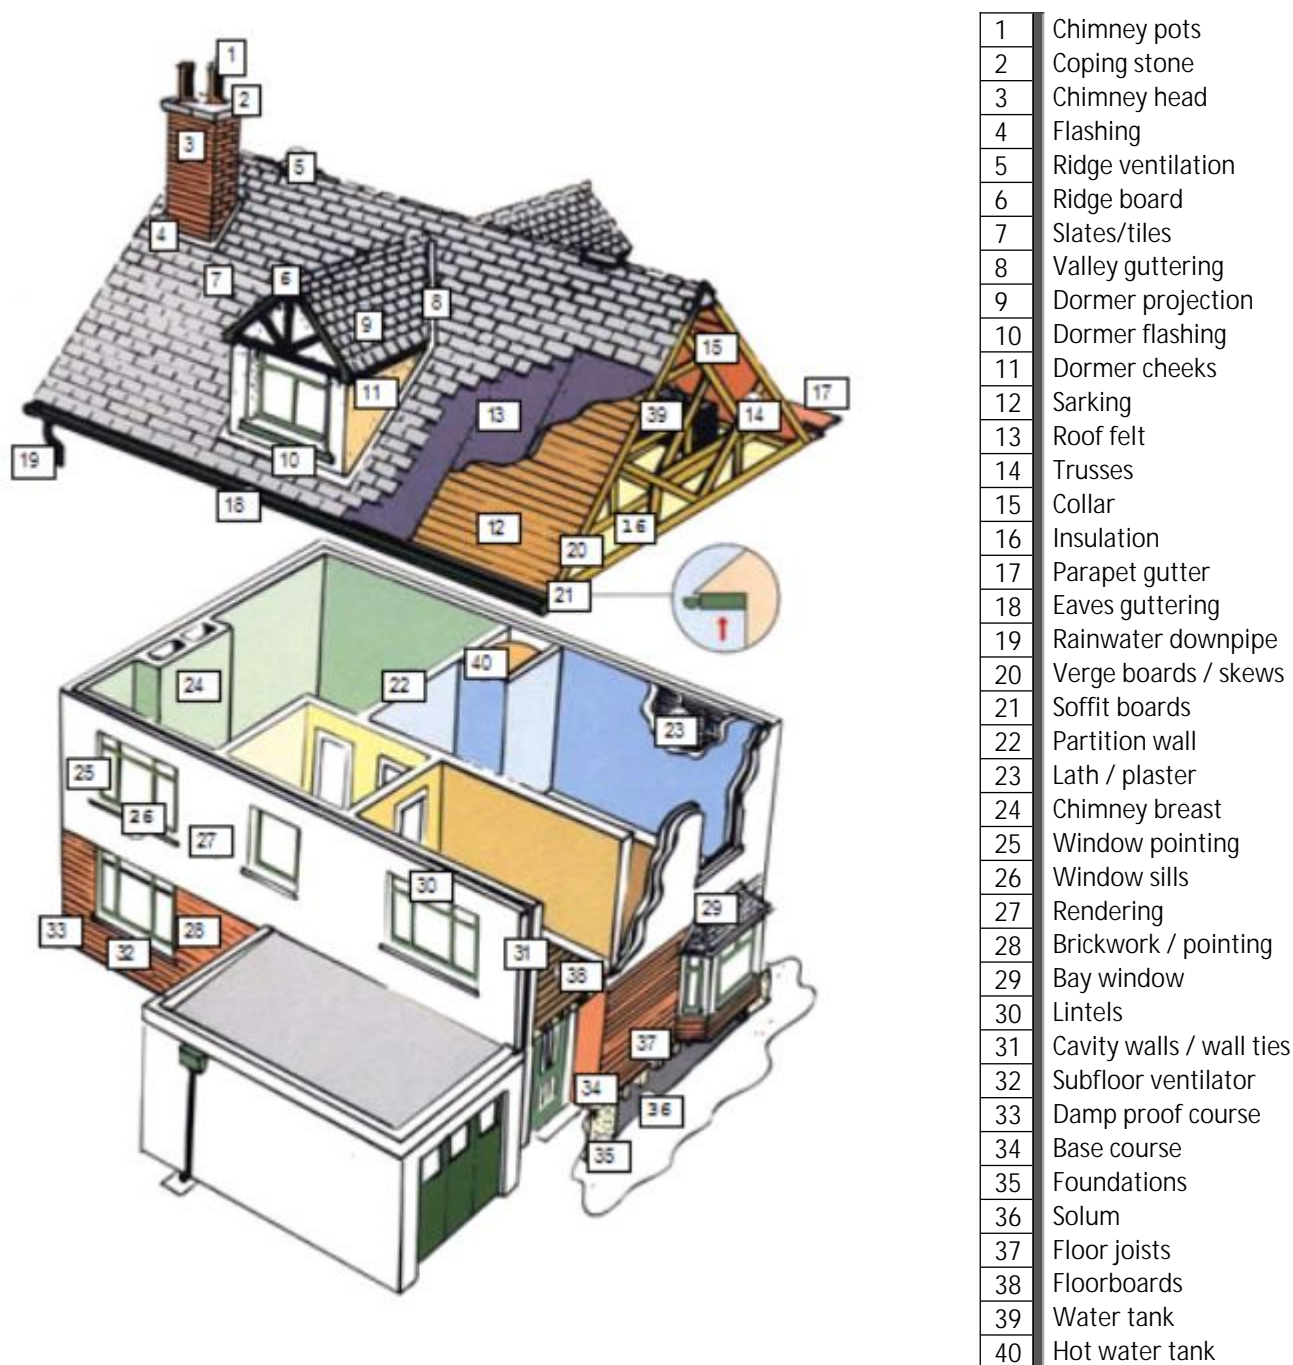
Sectional Diagram showing elements of a typical house

Reference may be made in this report to some or all of the above component parts of the property. This diagram may assist you in locating and understanding these items.
