Single Survey

Property address	4 MAIDENCRAIG COURT ABERDEEN AB15 6NS
Customer	K BURTON
Customer address	4 MAIDENCRAIG COURT ABERDEEN AB15 6NS
Prepared by	HOME REPORT COMPANY
Date of Inspection	26 TH AUGUST 2021

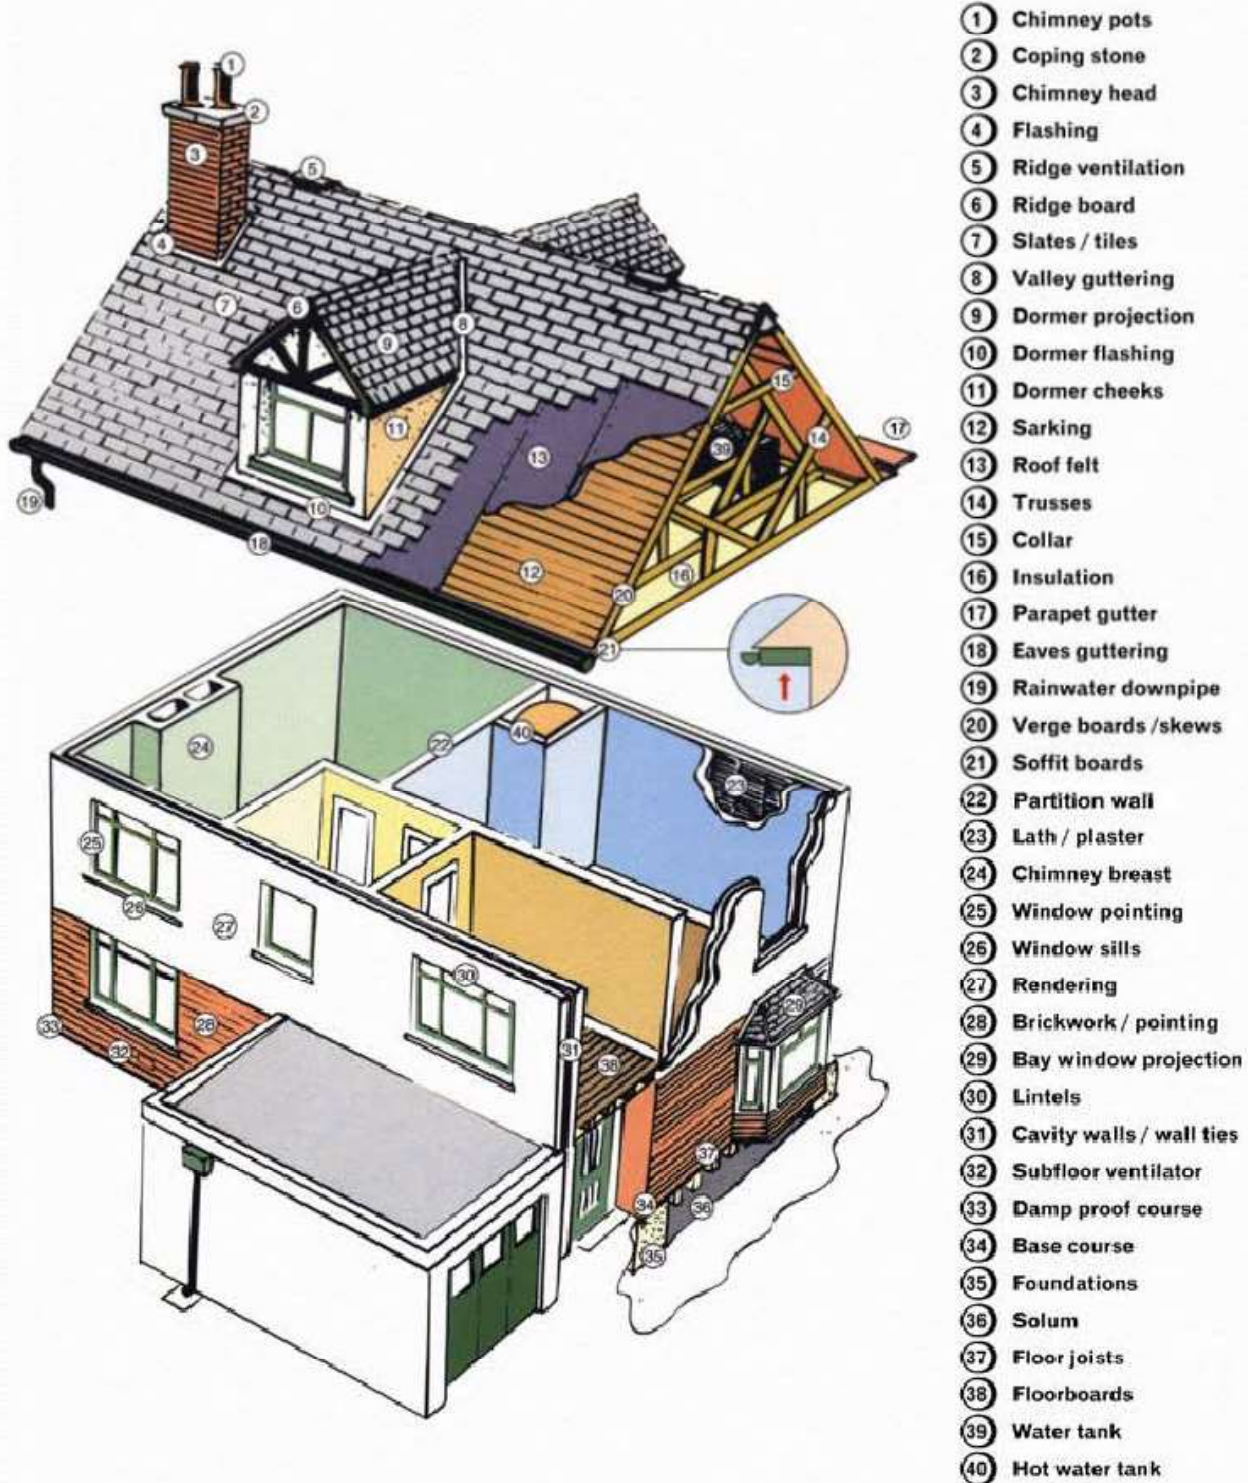
Sectional Diagram showing elements of a typical house

Reference may be made in this report to some or all of the above component parts of the property. This diagram may assist you in locating and understanding these items.
