single survey

survey report on:

| Property address | 49 Menzies Road Aberdeen AB11 9AT |

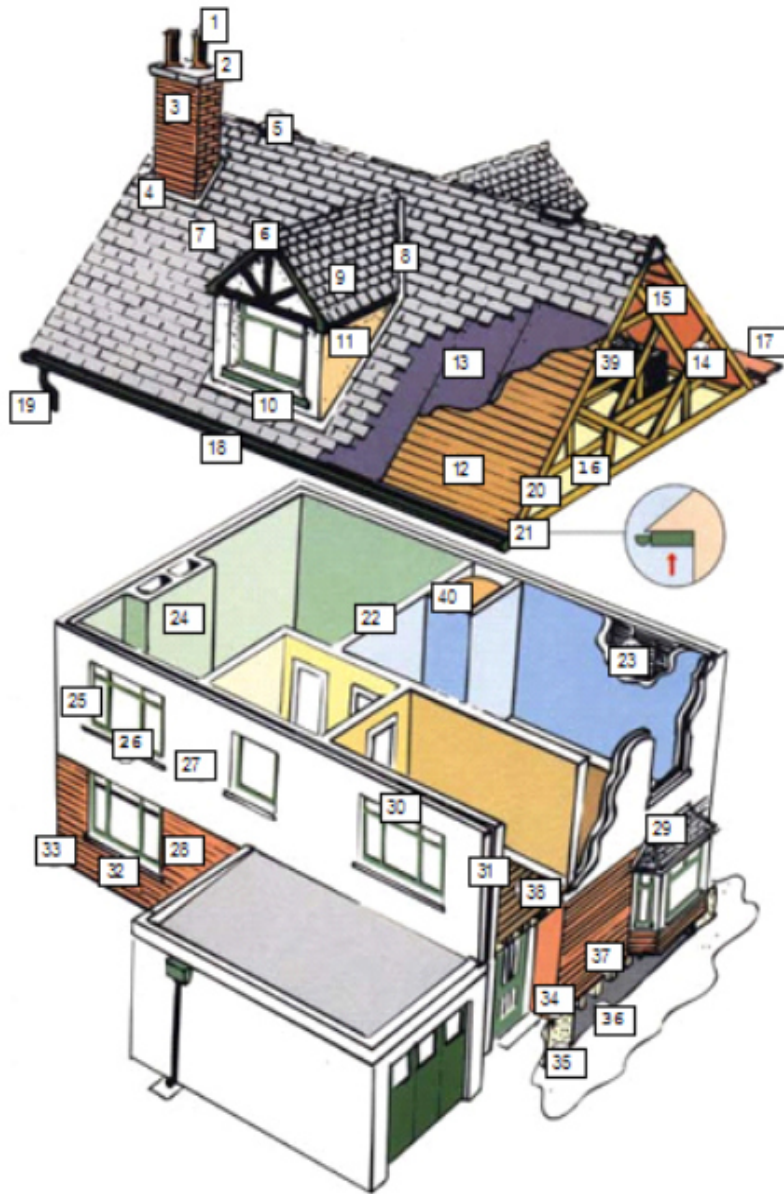
Sectional Diagram showing elements of a typical house

| 1 | Chimney pots |
| 2 | Coping stone |
| 35 | Foundations |
