Home Report

**Flat C 49 Seaforth
Road,
Aberdeen, AB24 5PG**

ASPC ref. 402692

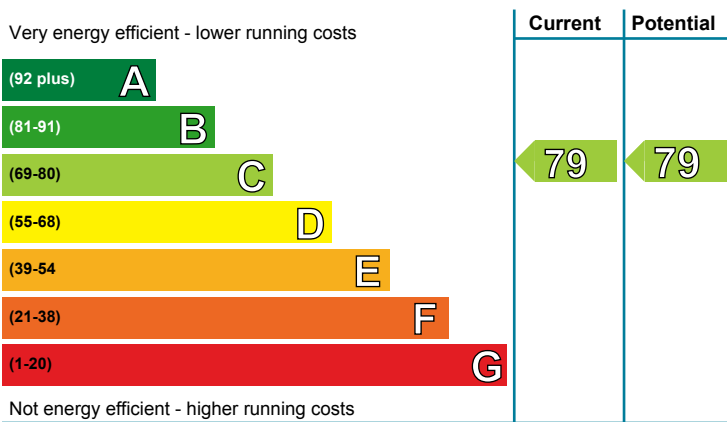
Energy Efficiency Rating

This graph shows the current efficiency of your home, taking into account both energy efficiency and fuel costs. The higher this rating, the lower your fuel bills are likely to be.

Your current rating is **band C (79)**. The average rating for EPCs in Scotland is **band D (61)**.

The potential rating shows the effect of undertaking all of the improvement measures listed within your recommendations report.
